Brenda Natalie Podio

Numerical Analysis of Climatic Conditions
Influence on the Current State of the St. Ann Church

ADVANCED MASTERS IN STRUCTURAL ANALYSIS
OF MONUMENTS AND HISTORICAL CONSTRUCTIONS

Master's Thesis

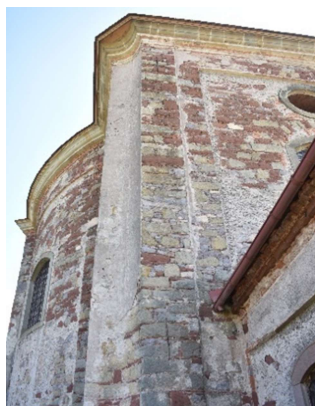
Figure 3.9 - East façade

A few steel ties were seen in the masonry walls, beneath the deteriorated render in the west façade (Figure 3.9, Figure 3.10). The steel ties were only observed in the west façade, since the other façades are still covered in plaster. The ties serve to keep the three leaves of the masonry walls clamped to prevent bulging and detachment.

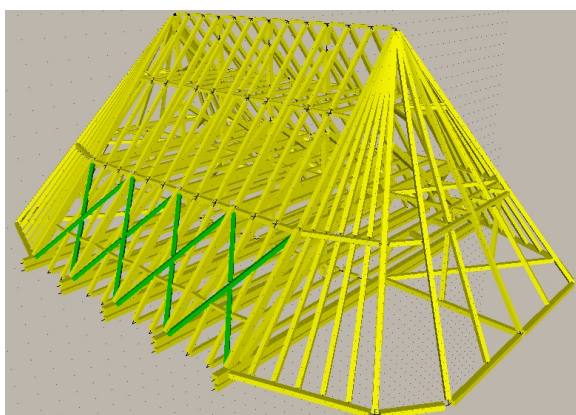
The timber roof is composed of large trusses that appear to be oversized due to the large members in both the longitudinal and transverse directions (Figure 3.11) [10]. The timber roof allows for a shallow, light and wide ceiling that reduces the lateral thrust exerted on the masonry walls, as compared to a masonry vault ceiling. As well, the hanging false vault ceiling composed of timber boards and plaster is light and imposes small dead loads (Figure 3.12). Since the false vault ceiling is suspended on the sail vaulted trusses, the dead load is able to be applied directly to the walls and no additional horizontal loads are expected to be exerted on the masonry walls. Small holes can be seen at the top of the masonry walls that were a rudimentary technique employed by the Dientzenhofers to combat high humidity in roof areas [10]. These holes permit fresh dry air to circulate the roof as much as possible, though this did not prevent the development of moisture and fungus in the roof trusses.

Figure 3.11 - Timber roof of the St. Ann Church [10]

The roof has undergone several conservation works. In the past, destroyed sections of roof members due to fungi and moisture were strengthened by steel [10]. Two diagonal struts were also added in the main roof truss for additional reinforcement [2]. Furthermore, many of the ceramic roof tiles were replaced by steel plate sheets to patch the roof holes and leaks (Figure 3.2) [10]. Previously, the roof holes and leaks led to the destruction of the original sandstone cornices that contributed to issues in the roof system (Figure 3.13). These fallen cornices have since been repaired with brick (Figure 3.14). The high moisture content in the church and weathering led to additional issues and leaks in the timber roof that could have continued past the roof to affect the rest of the structure. Observing past damages, it becomes clear that weathering and lack of maintenance lead to an increase in the rate of deterioration.

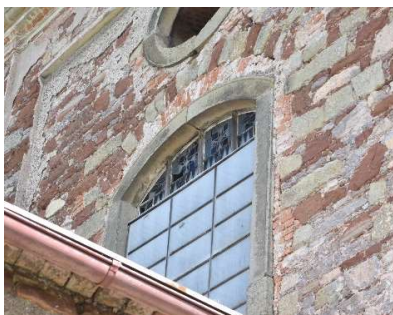
Other signs of reconstruction were observed by the presence of bricks in seemingly random locations that serve to patch the masonry wall in locations where original blocks appear detached (Figure 3.15 to 3.17). This was commonly seen surrounding the frames around doors, windows, cornices and close to foundations, where there was some separation noticed between the lower stones and foundations.

Figure 3.15 – Infill of bricks around window opening

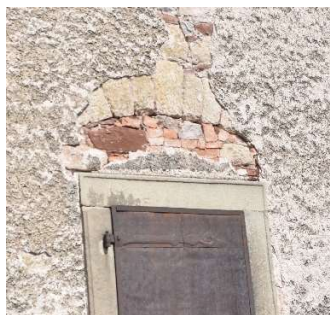
Figure 3.16 - Infill of bricks above door opening

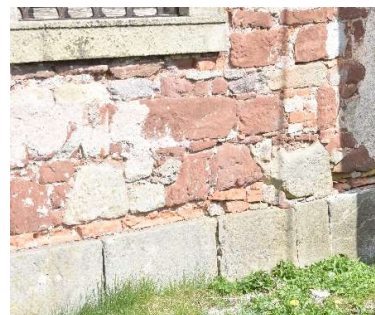
Figure 3.17 - Bricks located at separation of foundation stones

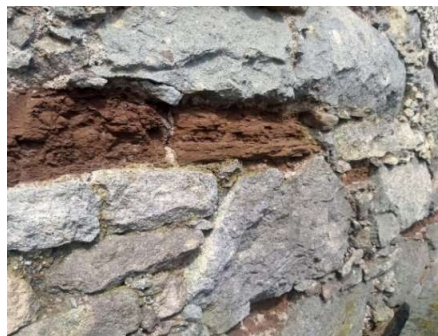
Differential weathering and alveolization can be observed primarily on the exposed red and grey sandstone on the exterior of the building. This is possibly due to inhomogeneities in the stone's chemical or physical properties, as well as the large variability in building stones (Figure 3.22). Differential erosion was commonly seen on most exposed masonry blocks, leading to a loss of the original surface and smoothed shapes. The weathering and erosion of the exposed masonry also led to a significant loss of the lime mortar matrix (Figure 3.23).

Figure 3.23 - Erosion of stone and loss of mortar

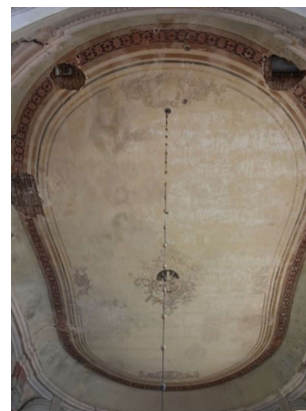
The darkening of surfaces due to moist areas and dampness was seen on both the exterior and interior of the building. The moist areas on the exterior of the structure are limited to the lower course on the north façade (Figure 3.26). On the other hand, the interior walls and floor are highly affected by moisture and have extensive signs of moist area staining and rising damp (Figure 3.27, Figure 3.28). This resulted in heavily damaged plaster with loss of cohesion at the bottom of the wall. The rising damp from the uninsulated foundations, a lack of ventilation and high air humidity are primary causes for the moisture damage in the building interior. More widespread damages were seen on the north and west walls that are not exposed to direct sunlight year-round and thus have wall drying delayed. Moist area staining was also noticed at several spot locations on the ceiling, serving as evidence of previous and ongoing roof leaks (Figure 3.29). It is unclear if the roof leaks are active, as the roof was previously repaired.

Figure 3.29 – Moisture stains on ceiling plaster

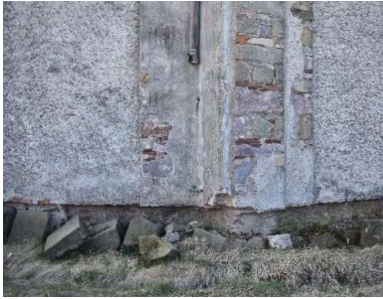
At several locations throughout the perimeter of the structure, the lowest stone course was seen to begin to detach from the masonry wall and at some points has completely fallen from the wall. This detachment was most severe along the north perimeter of the structure (Figure 3.35). Varying degrees of stone detachment was seen along the west sacristy (Figure 3.36), and a spot location on the west wall (Figure 3.37). The stone detachment at ground level could be due to the presence of runoff water from the sloping nature of the site, as well as the location and poor condition of rainwater gutters that may have caused poor soil conditions.

Figure 3.35 – Stone detachment, north wall

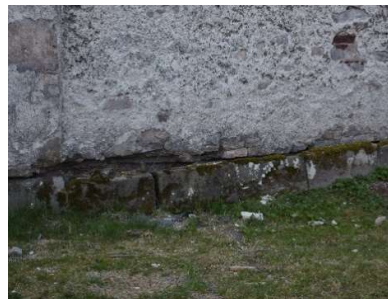
Figure 3.36 – Stone detachment, north wall

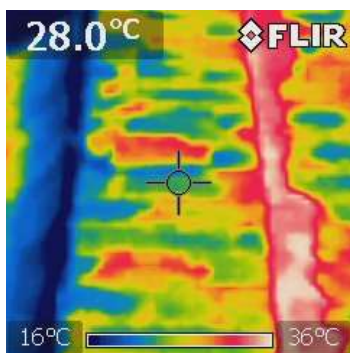
Temperatures on the exterior of the structure varied significantly not only due to wall orientation and shadowing, but also due to nonhomogeneous material characteristics and the presence of plaster (Figure 3.46). The effect of the large variability in materials can be seen in Figures 3.44 to Figure 3.46.

Figure 3.44 - Thermography camera, south wall

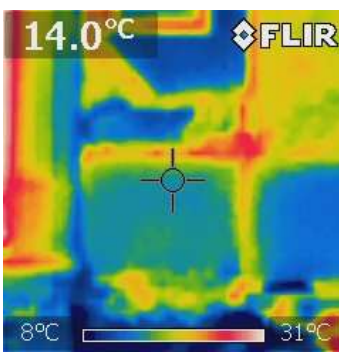
Figure 3.45 - Thermography camera, east wall

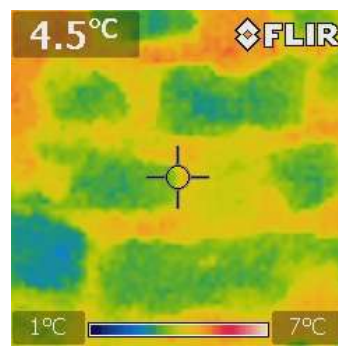
Figure 3.46 - Thermography camera, west wall

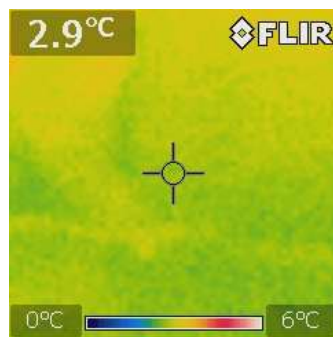
The interior surface temperatures change at a much slower rate than the exterior. In the interior it was possible to observe decreased temperatures for the lowest 1m of wall likely due to the effect of the uninsulated foundations and high moisture content as can be observed in the colour differences in Figures 3.47 to Figure 3.49.

Figure 3.47 - Thermography camera, east wall

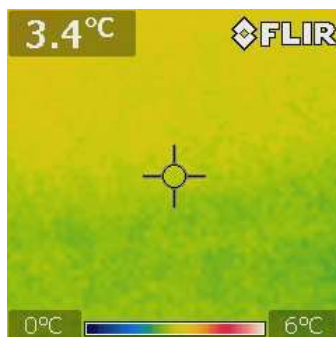
Figure 3.48 - Thermography camera, west wall

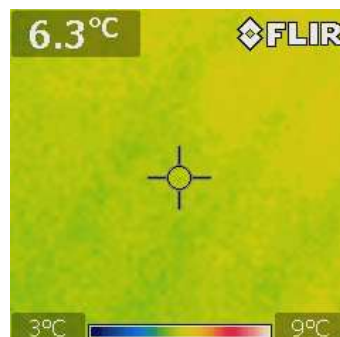
Figure 3.49 - Thermography camera, south wall

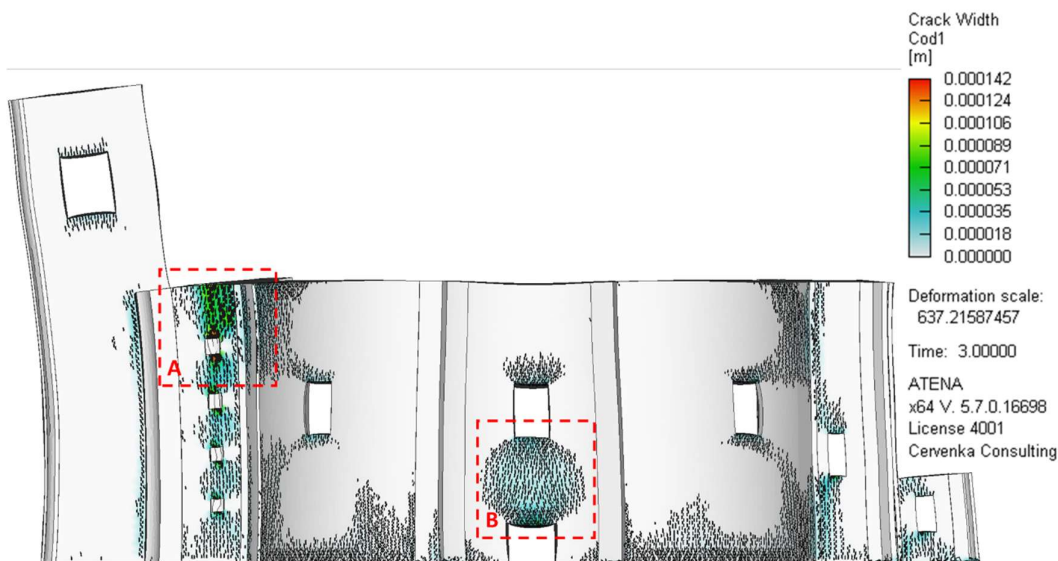
Figure 6.32 - Crack width, north elevation, Load Case 9

The areas where the maximum tensile strength was reached for the combined self weight and winter temperature loading were commonly observed surrounding the openings on the exterior surfaces of the structure (Figure 6.31). This is due to the inward movement of the walls that cause stresses to concentrate around the openings, with a particularly high concentration of cracks at the middle of the main nave between the window and door openings (Figure 6.32, B).

The area of highest tensile stress for Load Case 9 with winter temperature loads was at the foundation level of the sacristy, located along the outside perimeter (Figure 6.33). The winter loading causes the structure to contract, and in turn the foundations experience uplift. This effect is most dramatic at the sacristy, since the vertical loads (self weight, roof dead loads) are not enough to counteract the uplift in the foundations (Figure 6.34, A). Cracks in this region vary from 0.053 mm to 0.142 mm.

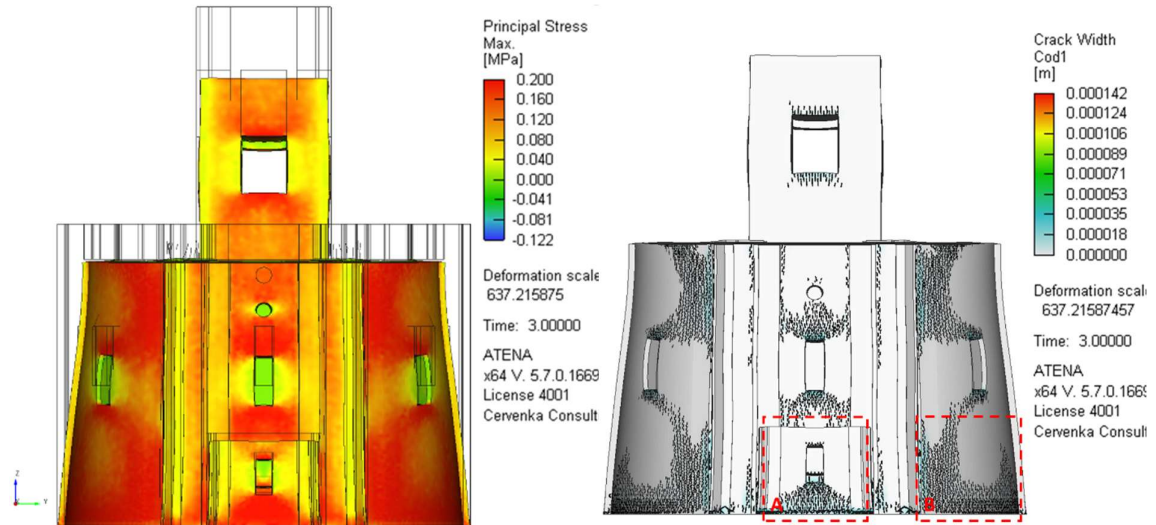
Figure 6.33 – Max. principle stress, west elevation, Load Case 9

Uplift in the foundations can also be observed along the perimeter of the main, but with lower magnitude since it is able to be counteracted by the higher self weight. The effect of uplift through the main nave

contributes to the high concentration of cracks on the exterior of the structure near the ground level (Figure 6.34, B). Cracks in this region typically vary around 0.018 mm.

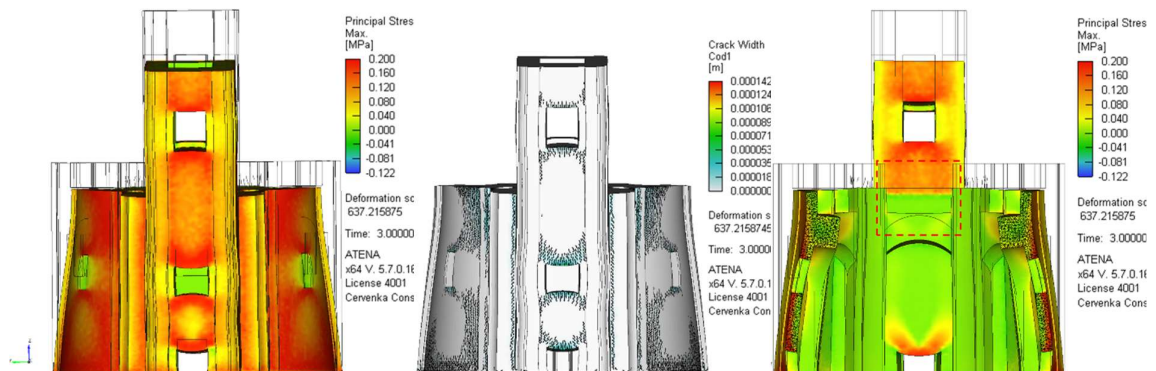
Figure 6.35 – Max. principle stress, east elevation, Load Case 9

The high concentrations of stress above window openings in both cases (Figure 6.28, Figure 6.35) are an overestimation, since in reality these windows are arched. It can be expected that the arches above

Areas of high stress and crack concentrations can be seen clearly in the lintels of the tower (Figure 6.35, Figure 6.36). The effect of the higher temperature differences localized on the exterior layer of the structure are a large contributor for the increase in tensile stresses and thus crack propagation. This can be seen more clearly in Figure 6.37, (inside facing east towards tower) where there is a clear boundary along the height of the tower between the interior and exterior of the structure. The contraction of the outer layer of the building, combined with the curvature of the walls, is enough to increase the number of cracks when compared to the summer loading model.

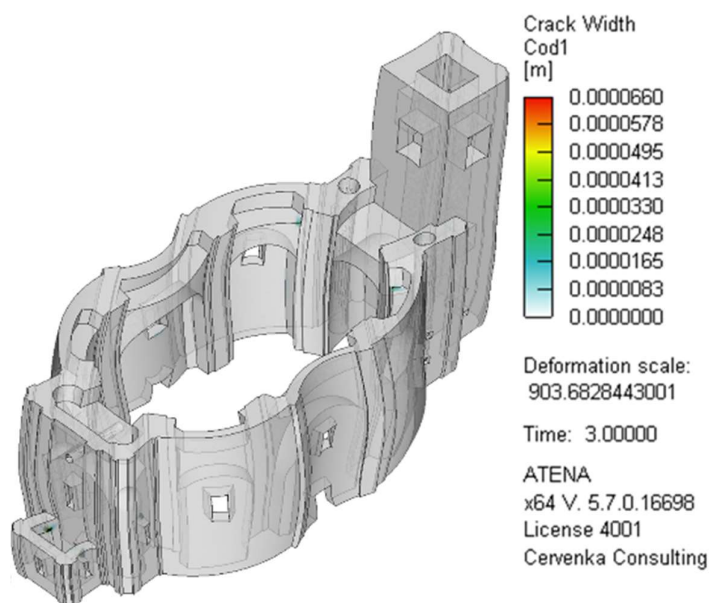
Figure 6.38 – Filtered crack width, Load Case 8

Minimal cracks remained after filtering was applied for Load Case 8, (self weight with summer temperature loading) as can be seen in Figures 6.38 and Figure 6.39. The largest cracks were 0.066 mm and were located above the openings at the west end of the structure near the dome openings (Figure 6.39, A) and in the sacristy windows (Figure 6.39, B). Cracks surrounding this opening were also seen in the real structure (Figure 6.40) with the cracks extending from the openings on either side of the nave, going through the small dome and connecting at the top (Figure 6.41). It is possible that these damages in the real structure are related to the temperature loading, though differential settlement can also have contributed to the movement of the outer west wall relative to the pillars and thus formed these damages.

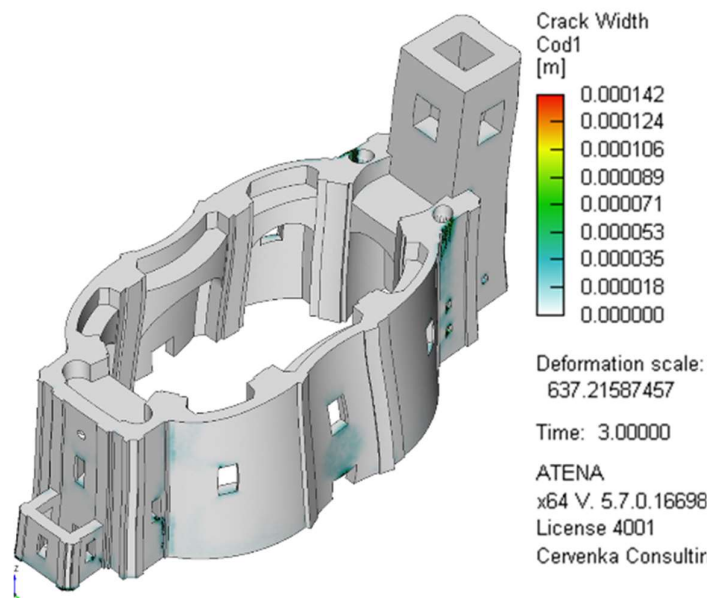
Figure 6.42 – Filtered crack width, Load Case 9

A larger number of cracks remained after filtering was applied for Load Case 9 (self weight with winter temperature loading) when compared to Load Case 8 (summer temperature loads), as can be seen in Figure 6.42 and Figure 6.43. A location where cracks remain in the winter model once filtering was applied are concentrated at the thin exterior wall of the staircase that restrains the outer movement of the bell tower (Figure 6.43, A). However, cracks in this region were not observed on the real structure but rather on the bell tower (Figure 6.44). These cracks are assumed to be from the use of the church bells or the movement of the tower under self weight, however results suggest that temperature loading, and weathering may have exacerbated this movement.

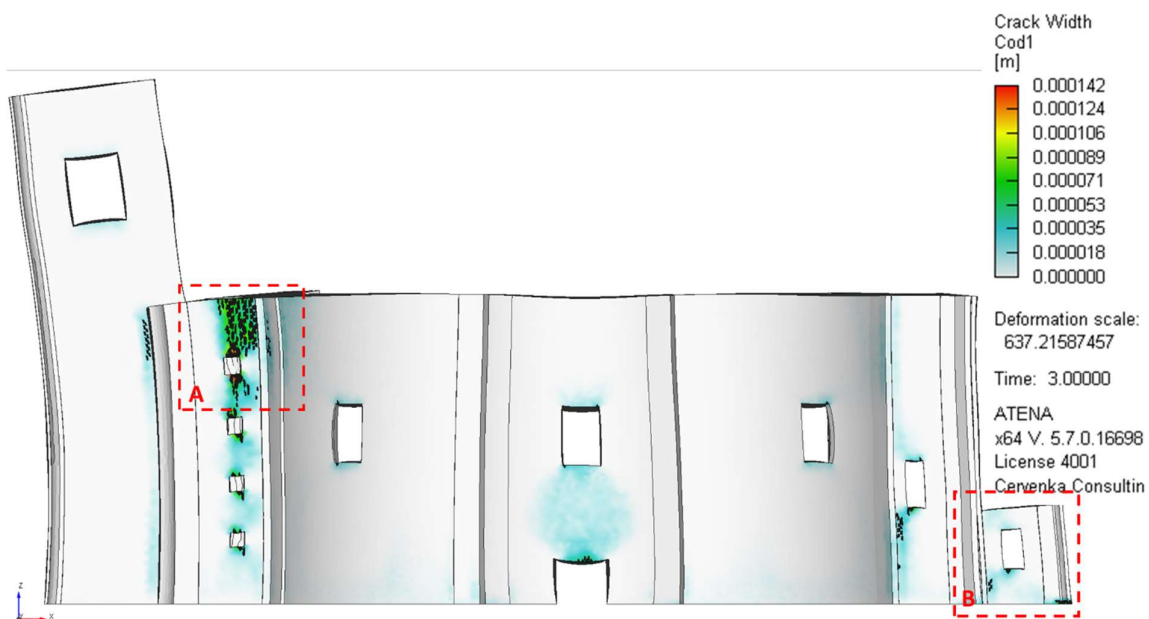
Figure 6.43 – Filtered crack width, north elevation, Load Case 9

In the numerical model, a concentration of cracks was observed at the foundation level of the sacristy where the foundations experienced the most uplift (Figure 6.43, B, C). In the present situation, along the exterior of the main nave (Figure 6.45) and sacristy (Figure 6.46) it was common to see the lowest course of foundation blocks detached from the structure with a sequence of cracks forming a relieving arch extending from the foundation to window opening (Figure 6.47). As previously discussed this area has issues in drainage problems that could have affected neighbouring soil and caused differential settlements, however the detachment could have been worsened from winter temperature loading that added uplift to the foundations.

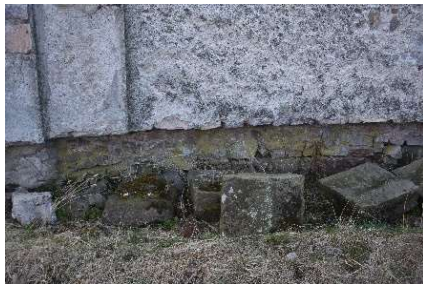
Figure 6.45 - Stone detachment, north wall

It is recommended to repoint the masonry walls with a compatible lime mortar and to restore the plaster of the façades to ensure a more tight envelope. The lime mortar and plaster should be compatible with the visual and physical material properties. The flexibility and low strength of the lime mortar will ensure compatibility with the structure when the wall undergoes contraction and expansion (breathing of the wall) due to the cyclic temperature changes. Re-sealing the building with the lime plaster would provide a better building envelope and ensure a more gradual transition of temperatures by reducing air
